75ZT Community

How to stop the BCU rattle behind your 75/ZT dash By Mike

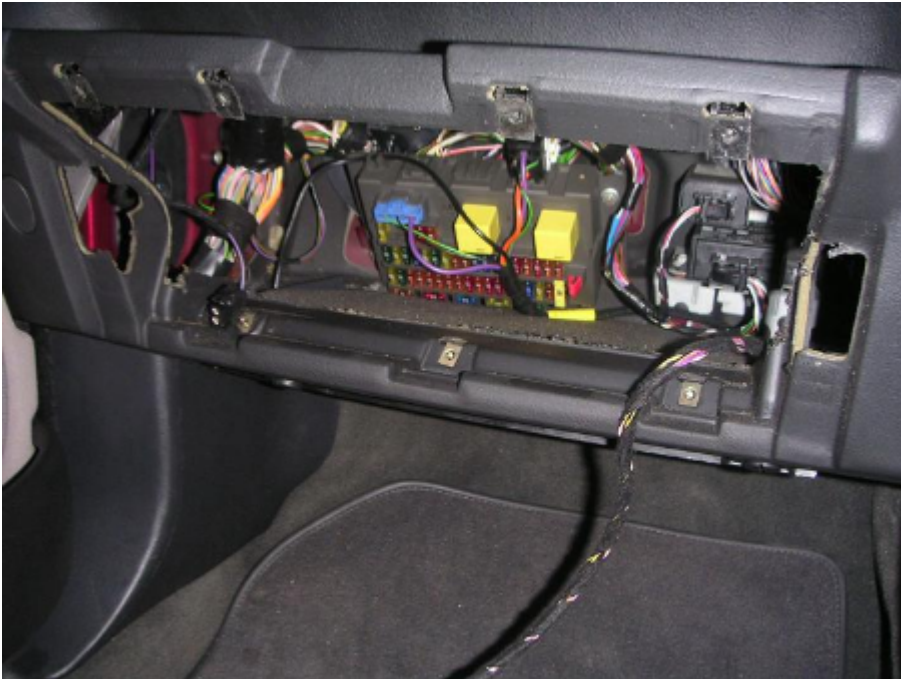
1. the glovebox area following removal showing the fuse board and the torx screw sockets at the top and bottom edges

Undo the 7 Torx screws (use a number 20 Torx bit) at the front of the glove box (four can be found top of inside front edge of the glove box and three under the front of the fabric mat on the inside base of the glovebox-just peel the front of the fabric until the screws are revealed).

Any of these can shake or rattle against the bulkhead, box brackets and other boxes itself. Ensure all mountings are tight and then put pieces of foam or rubber or sponge between them, the mounting brackets and the bulkhead to dampen any noise.

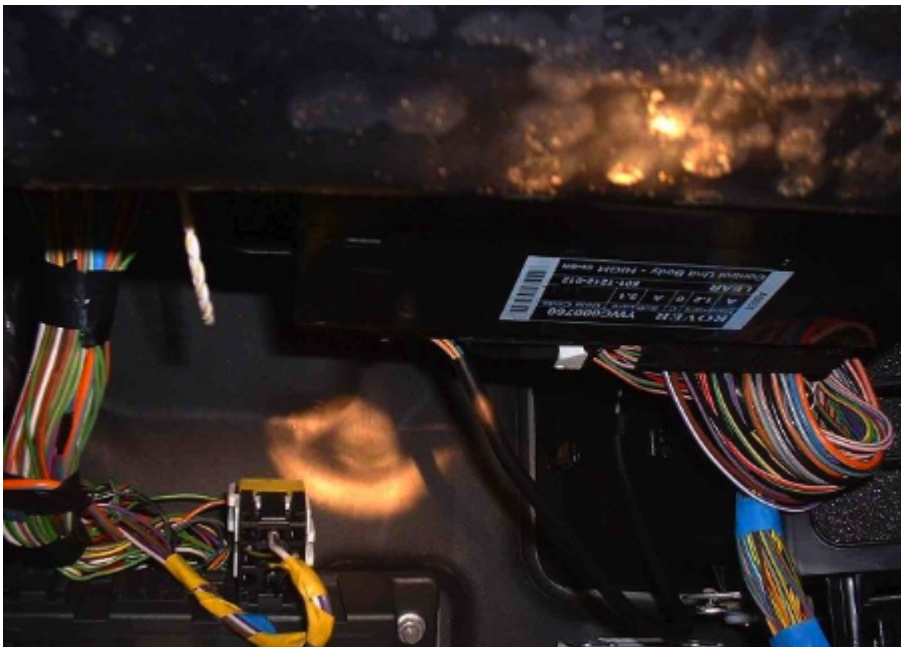
1. fuse board and other electrical boxes
2. Body control unit (BCU) above the fuse panel (get down low and look up -see pic)

2. The BCU in place looking upwards into the opening

You can also remove the BCU (remove using an 8mm box spanner - The angle makes access to the bolts tight, but dropping the fuse-box lid will give you more room) and check it by giving the case a tap or two . The circuit board in some BCUs rattle inside the plastic box and the two halves of the box vibrate. Open the box carefully and wedge the board with foam or sponge etc. and tape the box back together.
