# 75ZT Community

## How To Replace Worn Out Brushes in the Fan Motor

By French Mike and T-Cut

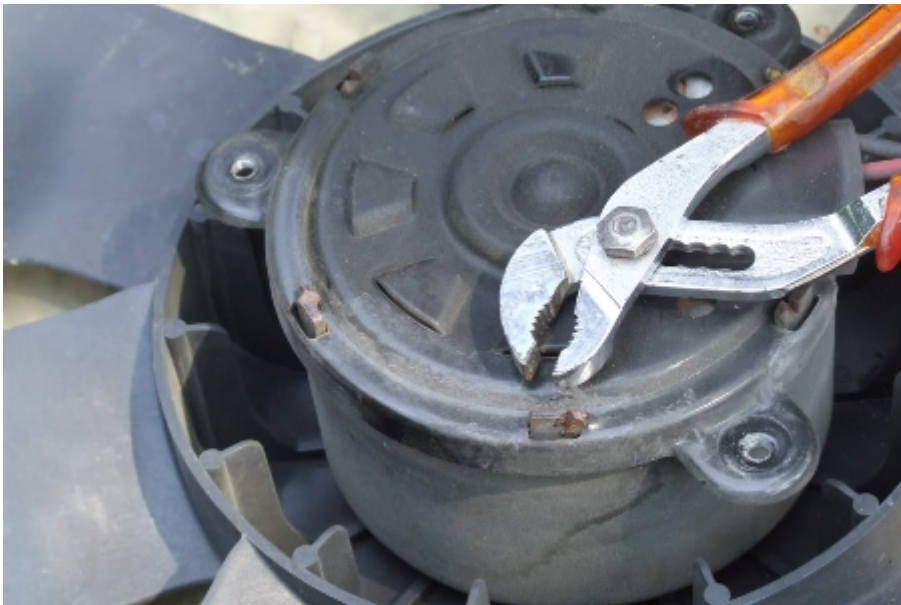
1. Remove the bumper and slam panel as described in Jules' tips.
2. Cut the fan cowlings around the aircon pipes in order to swing out the fan/motor assembly. A heated knife blade is good for slicing through the frame.
3. Extract the fan motor from the frame assembly (3 Torx screws). There's no need to remove the fan. It is better to leave in place to avoid snapping the plastic clips which hold the blade to the drive flange.
4. Using a pair of pliers, straighten out the lugs holding the end plate to the motor body as shown below.

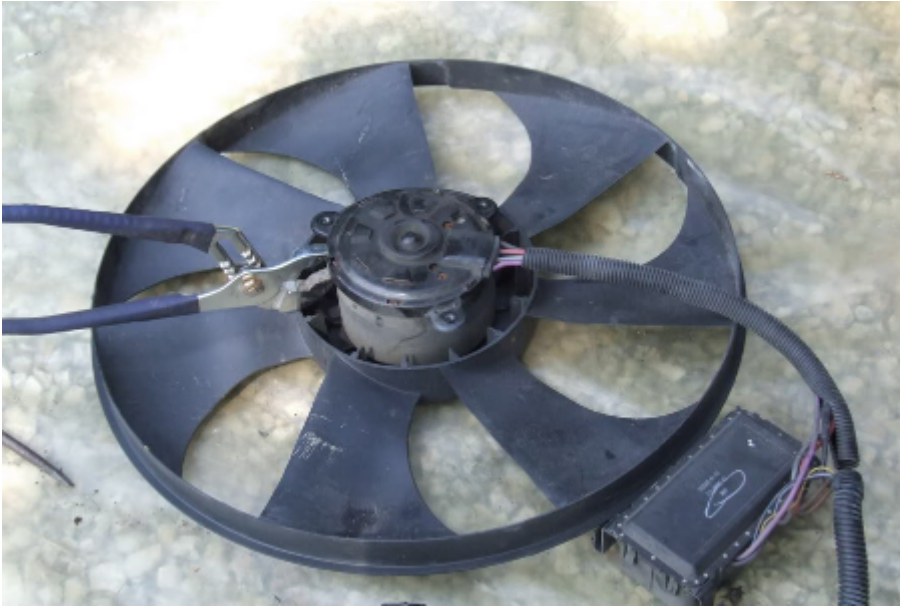
- / and withdraw the end plate
-

Don't hammer on the motor or the field magnets may fracture.

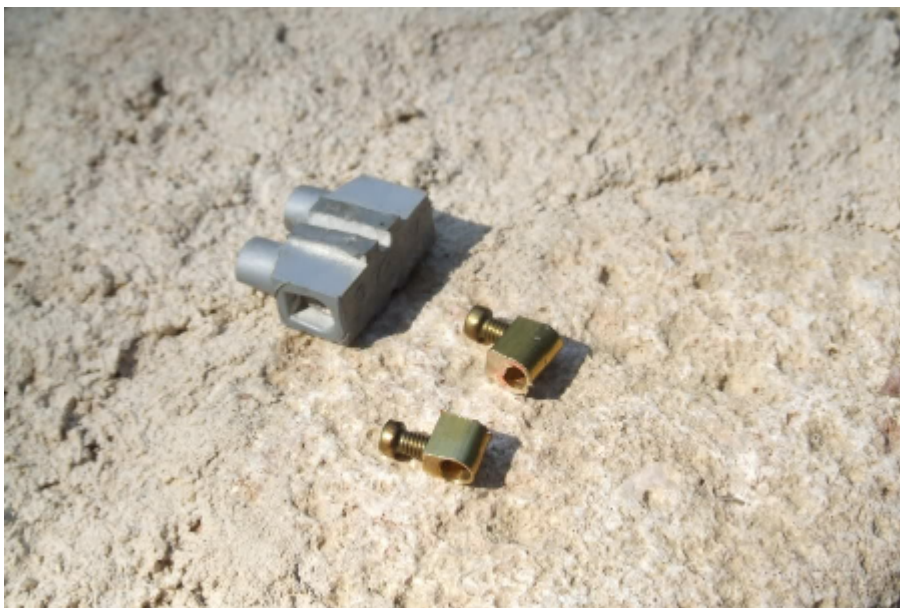
6. The original brushes are hard soldered to the choke wires and are difficult to remove. The simplest solution is to cut the braid, leaving enough length to attach the new one using a home made connector. To make this, I used the brass inner from a small block connector (3mm hole). This was cut into two pieces with a junior hacksaw as shown below.

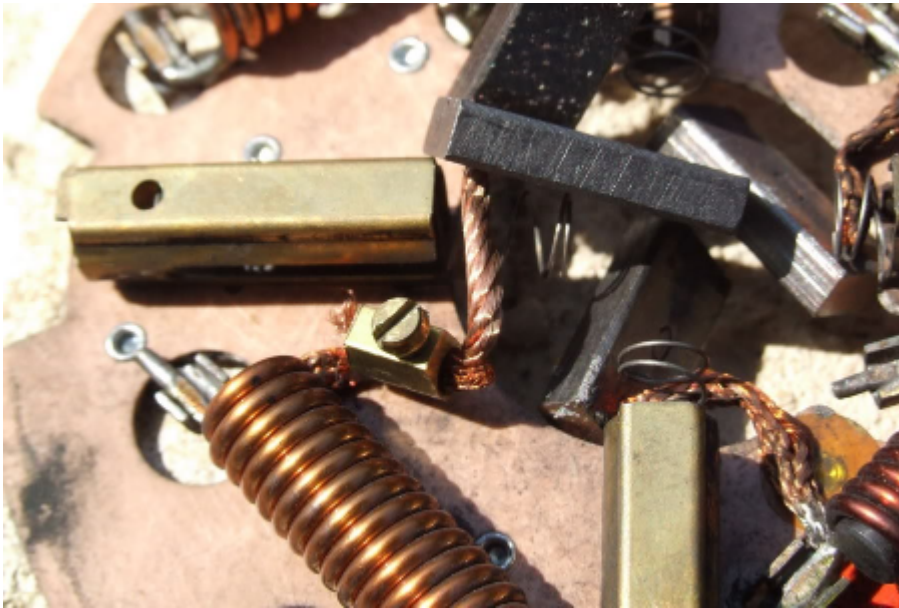
7. Insert the old and new braids into the connector from opposite sides. Ensure they overlap within the connector, then tighten the clamp screw. Hold the connector with pliers and cut off the head with a junior hacksaw.

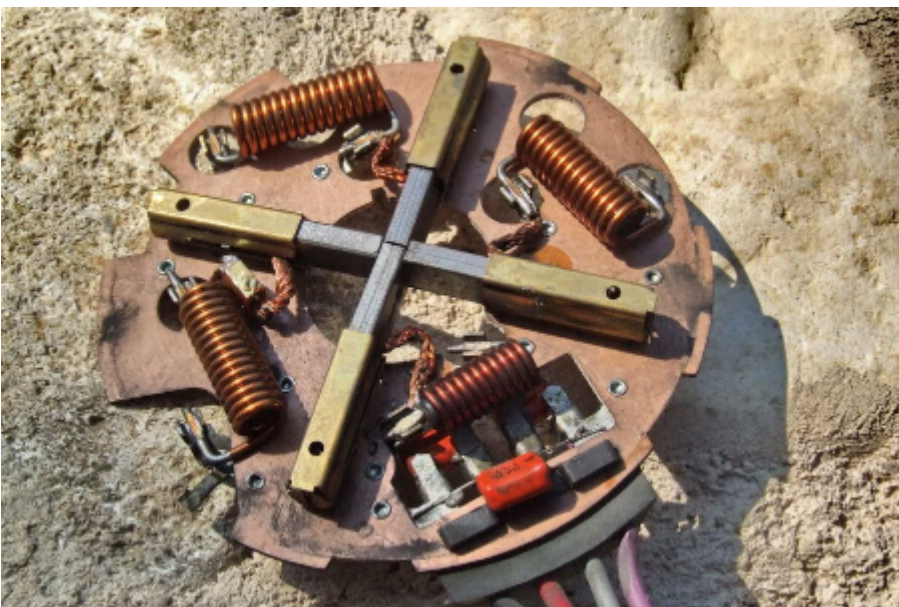
8. Using a heavy duty soldering iron (300w), solder the screw in place as seen here.

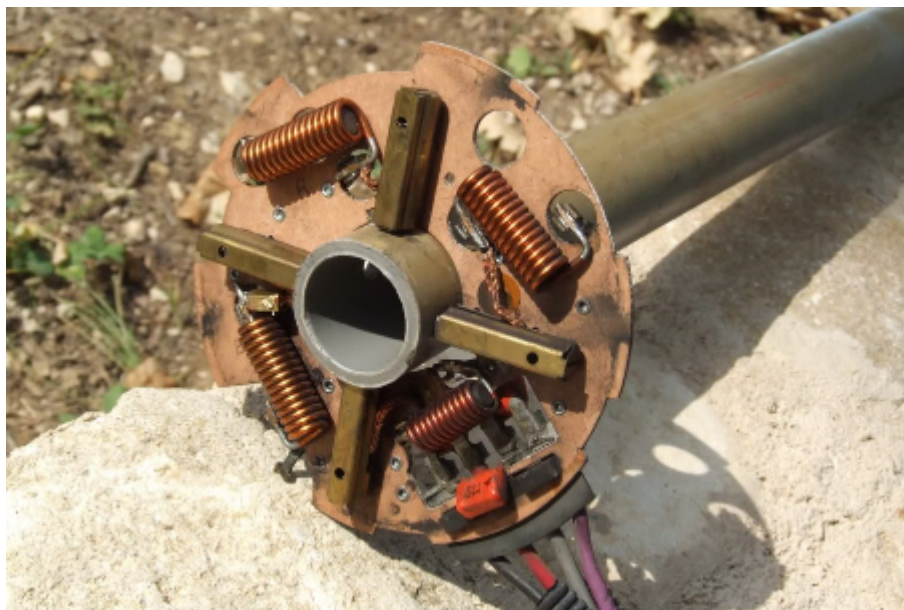
10. With the new brushes in place, retract them into their retainers and hold them in position using a short length of plastic waste pipe (about 32mm dia.) This will allow you to enter the commutator into the brush gear.

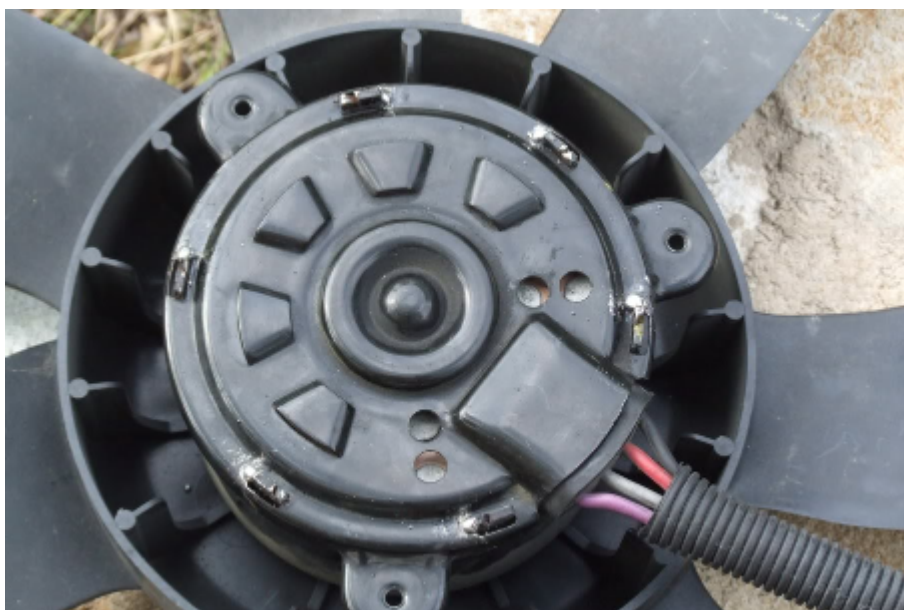
13. With the end plate securing lugs located in their slots, hold everything together firmly and apply a good blob of solder to each joint. This will make any future dismantling easier and avoid the lugs shearing off. The area around the slots should be abraided down to bare metal to ensure the solder takes properly. This preparatory work can be done while the brushes are being replaced.

A heavy duty soldering iron is essential.
