75ZT Community

Cleaning the MAF sensor for Rover 75 / MGZT By Austin

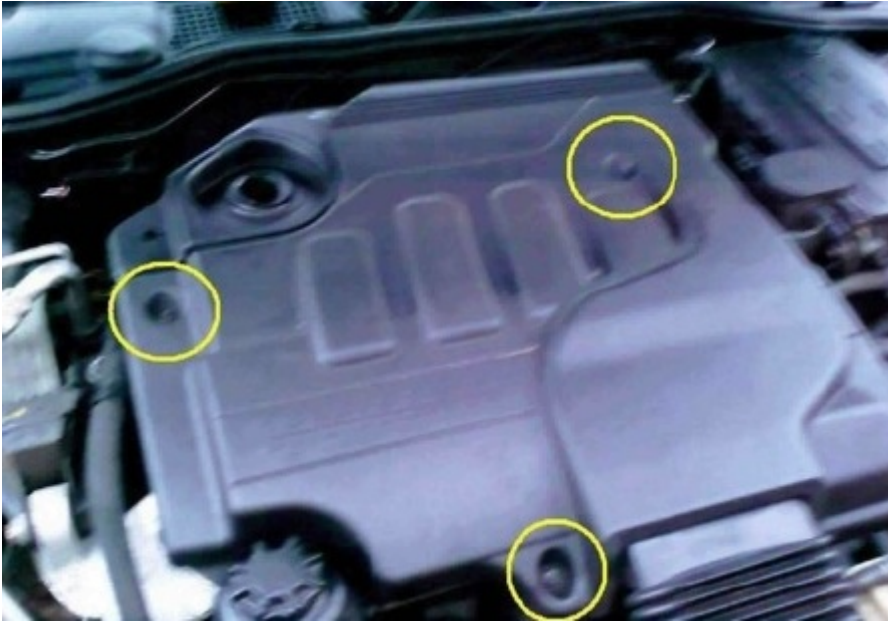
Let's start, first open the bonnet and remove the three bolts holding the engine cover with the 8mm socket. These are circled in the picture below.

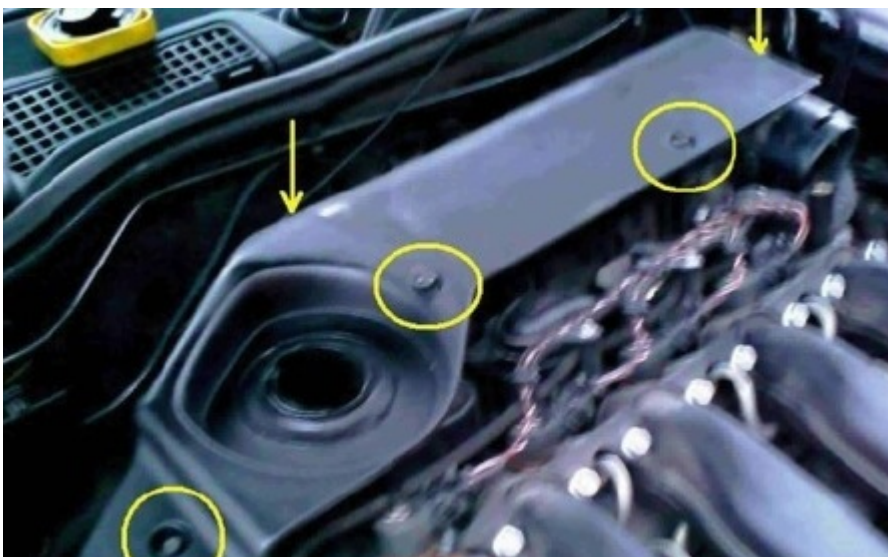
Once the engine cover is removed, you will need to remove the back box housing the air filter. There are 5 Allen bolts holding this down. You need the 5mm Allen key for this. The bolt locations are shown below, the two indicated by the arrows are slightly harder to find. You will also need to remove the Oil filler cap, caution, cover the opening and or refit the cap once the filter cover has been removed to avoid any items being dropped inside.

Once the MAF sensor is dry re-insert it. A point to make is I have replaced the silly BMW secure Torx screws with normal positive drive screws making for a much easier job next time. Plug the MAF sensor wire connector back in. Seat the air filter box back on, make sure it's correctly fitted, its easy to think its back on correctly, but the two back Allen bolts don't do up! Refit the engine cover.

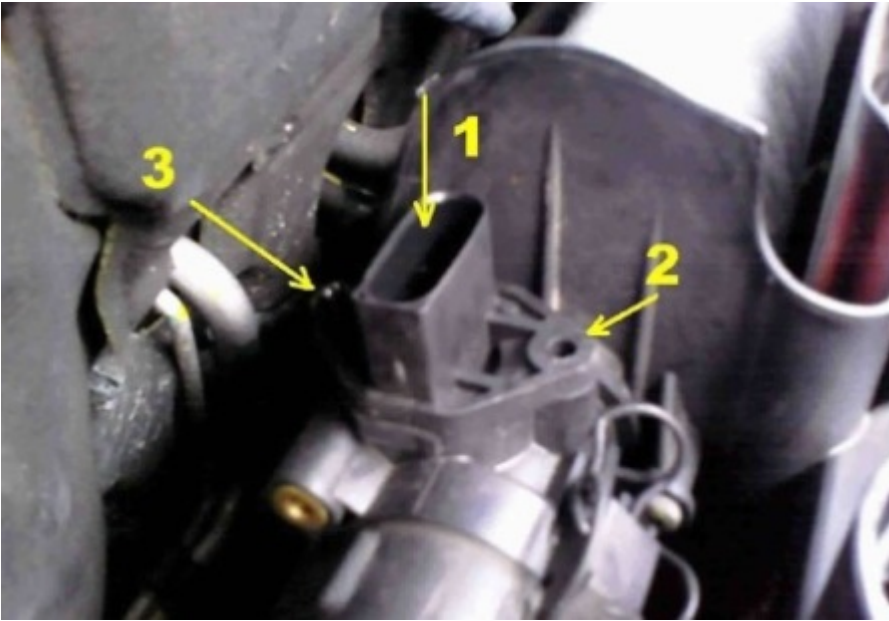
Once the air filter box is removed you can see the MAF housing which is nearest the Oil filler hole. First you will need to unplug the cable connected to the MAF sensor indicated by the number 1.

Next is the tricky bit, removing the two screws holding the MAF sensor in place. These screws seem to be a very special

type of secure Torx that only has a 5 pointed star as opposed the normal 6 pointed Torx. In the end I gripped them hard with a pair of pliers and undid them. See the notes at the start of the how-to about the correct tool.

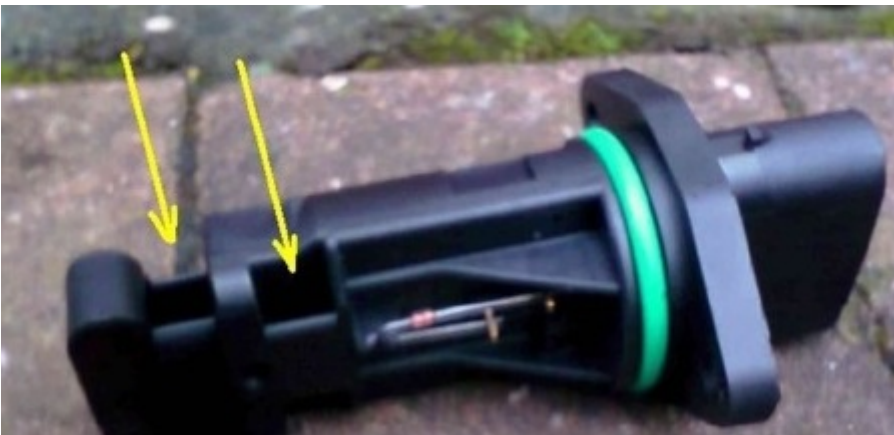
Once the two screws are removed (which took me about 45mins) you can CAREFULLY pull out the MAF sensor. Please remember that the sensor is VERY fragile and you MUST not touch any of the internal parts indicated by the arrows. Not even with a cotton bud. Now take the spray and give a good squirt into the areas shown in the picture, then allow to dry naturally or with an air duster aerosol.

A point to make is that I don't think there is any visible dirt to see. There was not on mine and my car has done 42,000 miles.

The reason we use the aerosol is that it does not involve touching any parts and does not leave any residue.
