# 75ZT Community

## How to remove and refit the Mk 1 75 front bumper

By Mike and YP53

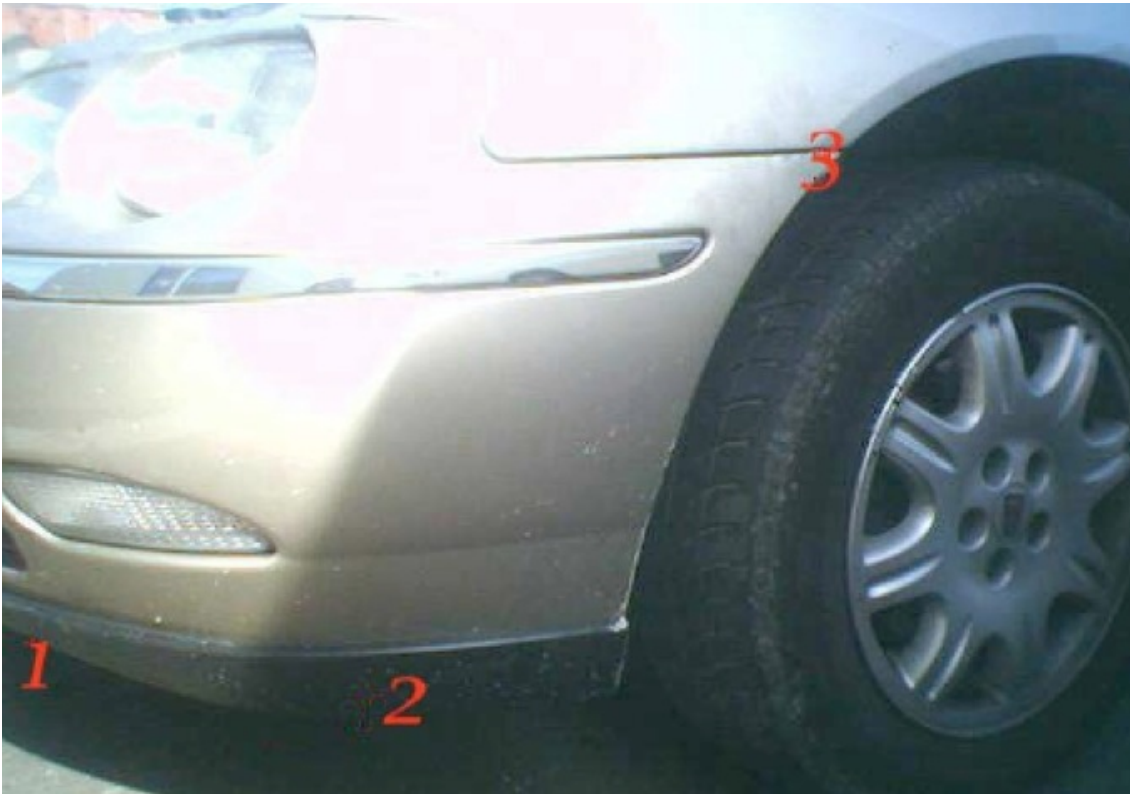
Remove the screws that attach the engine undertray to the front bumper. These can be found along the lower rim of the bumper denoted by (1)

Next remove the screws that attach the wheel arch liner and bumper, there are three screws underneath the car (2) and one bolt in the wheel arch (3). Repeat for both LH and RH sides.

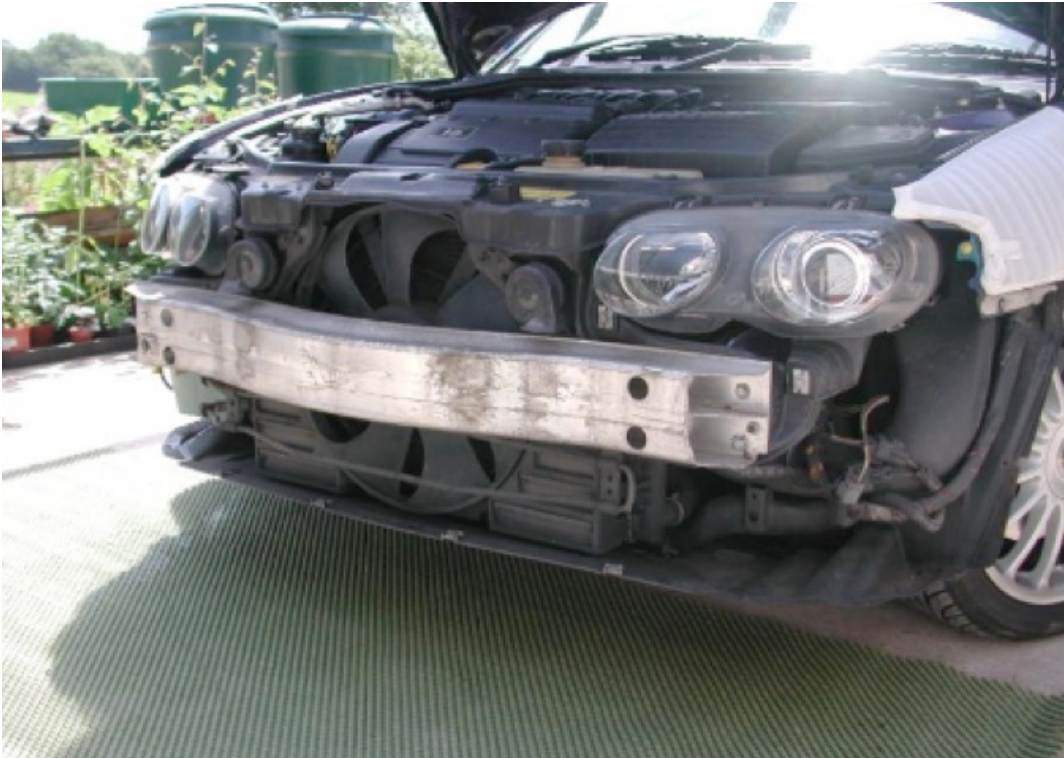
Open the bonnet and remove the screws that fix the Bumper to the bonnet locking platform, there are two at (1), three at (2) and two at (3).

Now put protective tape all around where the bumper meets the side wing - this will stop the bumper scratching the

Wing paint finish if it springs back when removed See pic below)

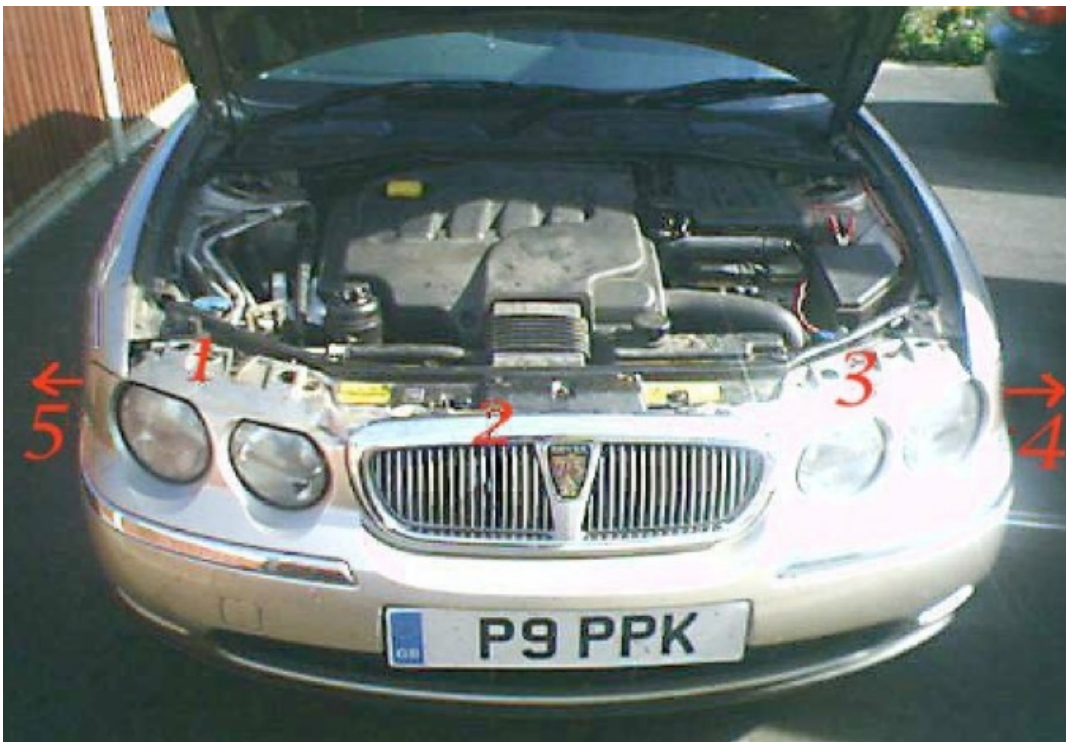
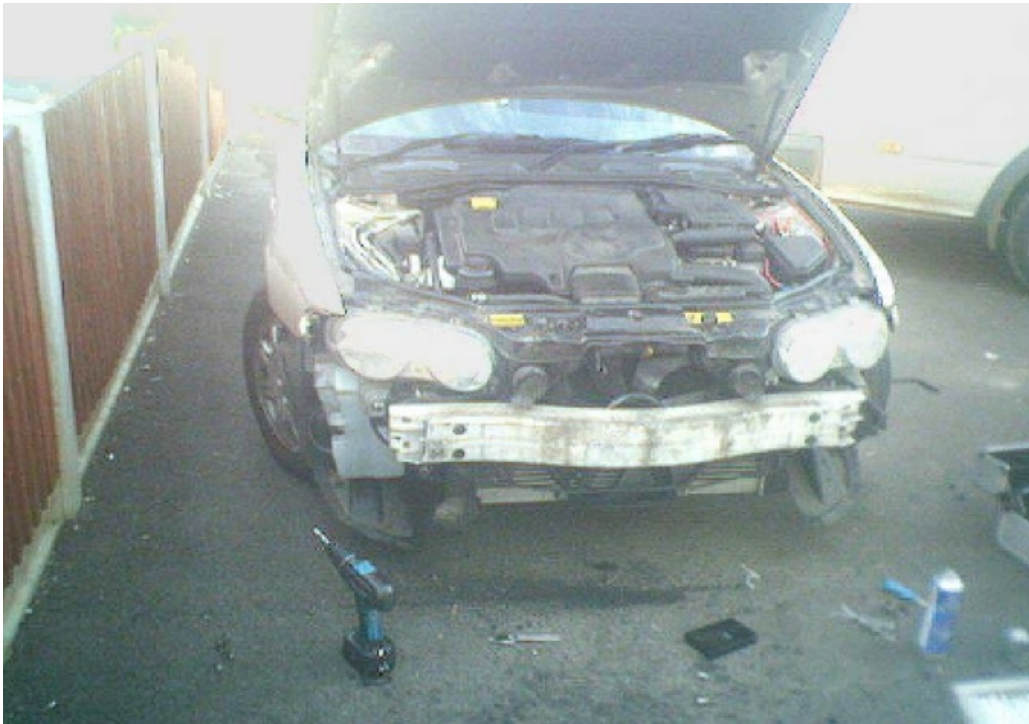
Next, gently pull the left hand side of the bumper away from the wing where they join at the wheel arch. Repeat process for right hand side too. These should 'pop' out.  
Standing in front of the car, pull the bumper toward you gently. The bumper should move freely in your direction. Lower it to the ground (keep it upright to avoid damage to the finish) and then release the wiring socket that attaches the front bumper to the body. This can be found on the left hand side of the car (as shown in picture) below the headlight unit. Remove the bumper from the work area but keep it somewhere safe, be sure not to scratch it!  
You should be left with your car in the state shown in the second image below.

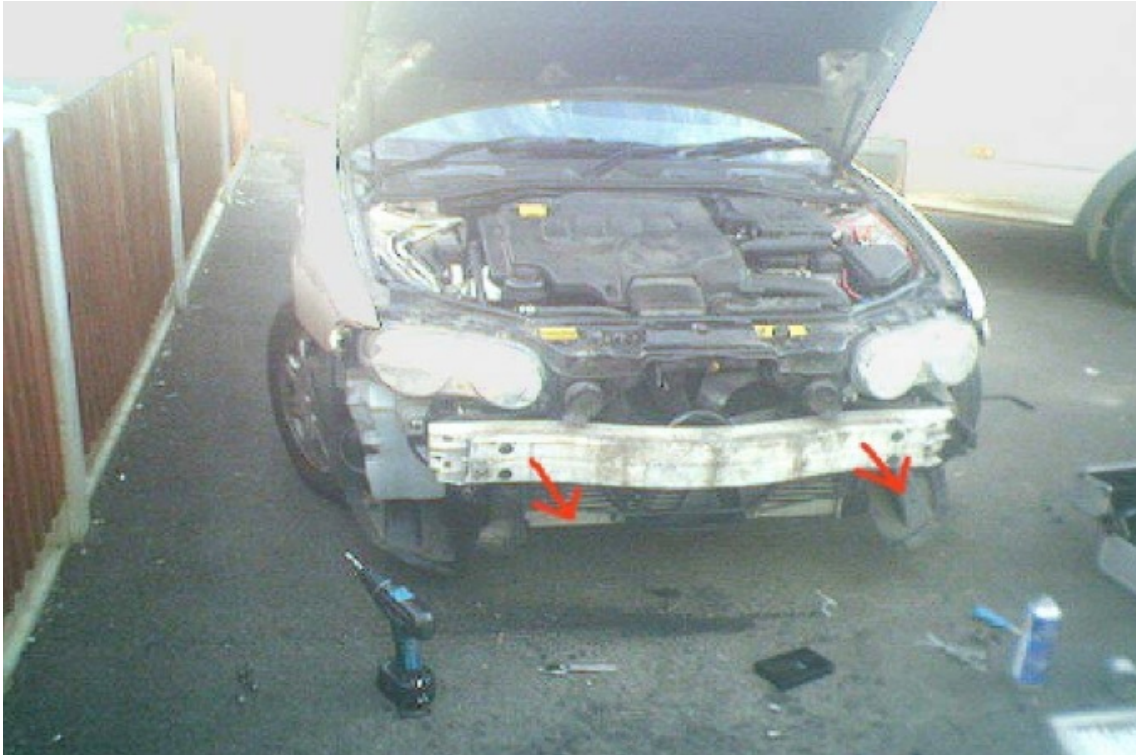
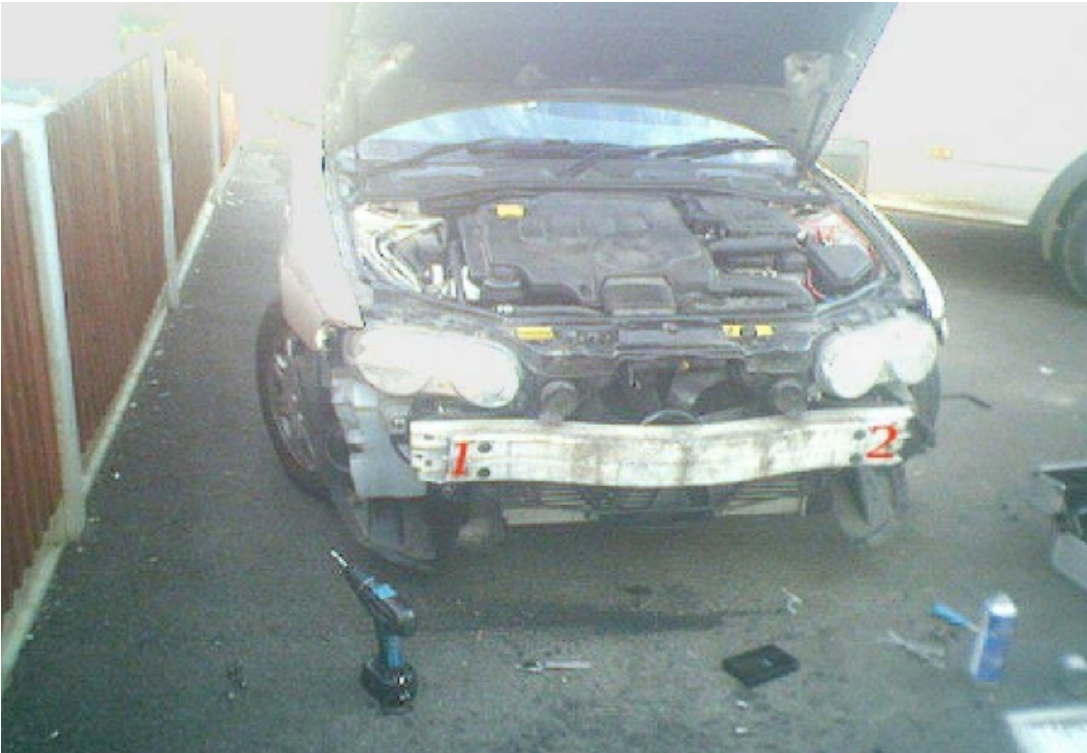
Loosen and remove bolts and nut in area (1) and area (2) Each contain 4 bolts and 1 nut - For a total of 8 bolt and 2 nuts. Keep these safe!  
Then remove cross member as shown in the 2nd picture below.

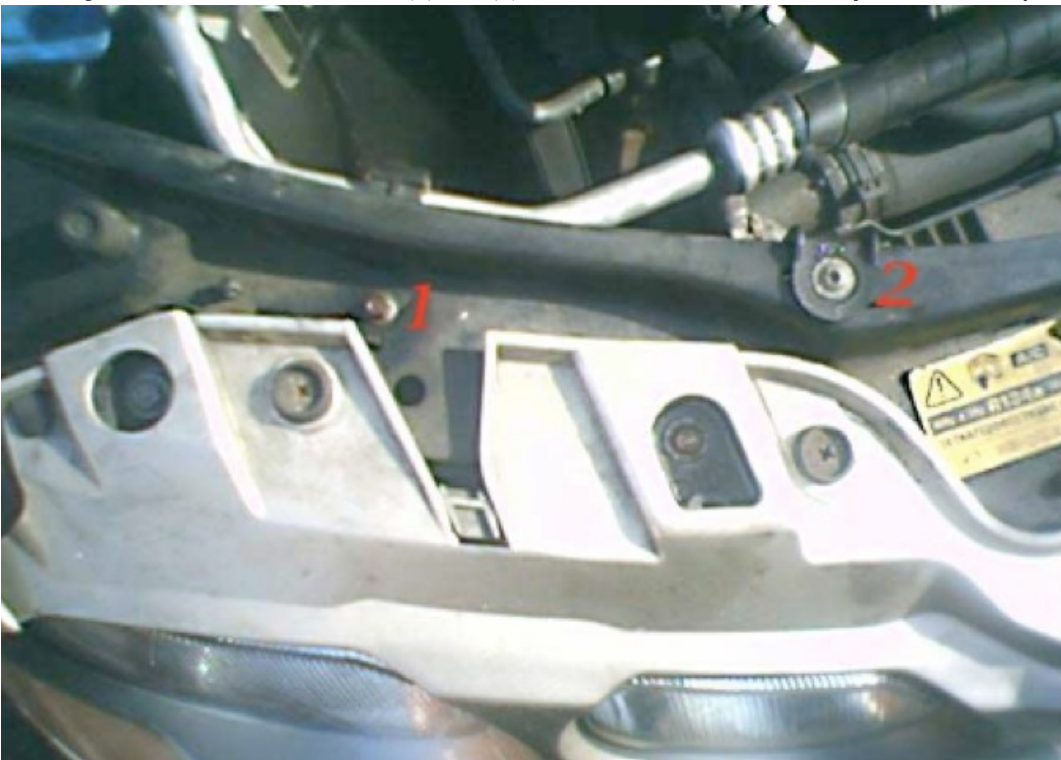
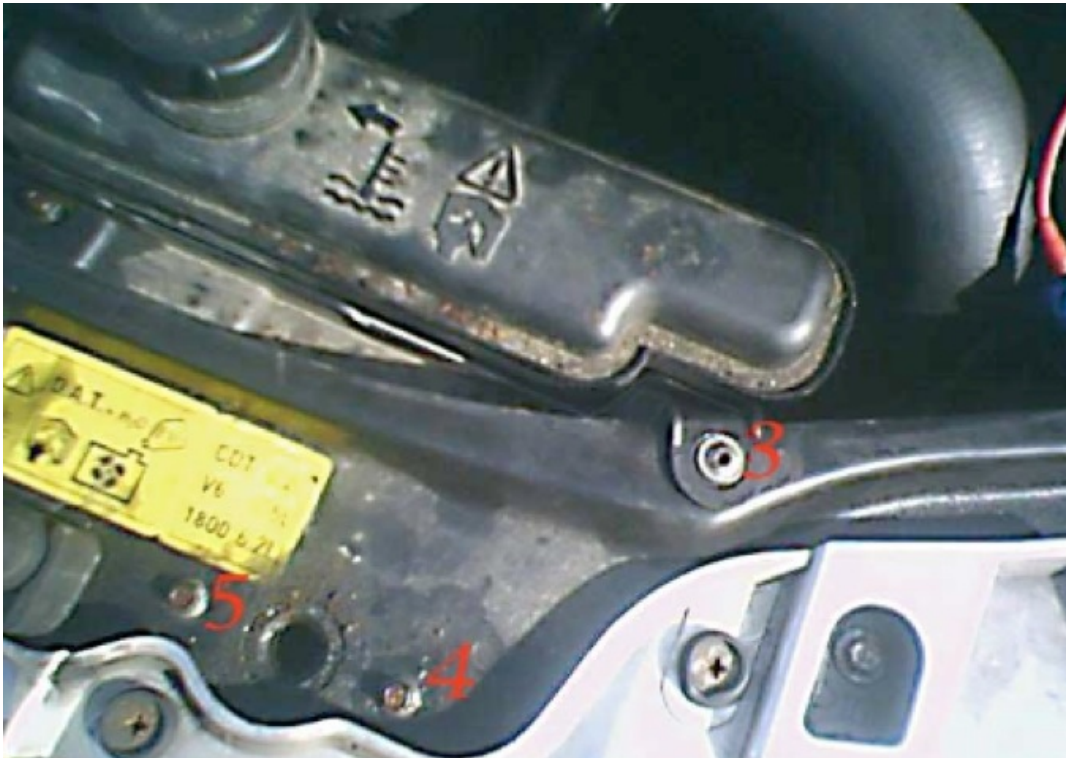
Picture1: Remove the bolt securing the pipe (1) and the torx screw attaching the bracket.

Picture2: remove the torx screw attaching the bracket on the other side (3). and for BOTH SIDES - remove the bolts attaching the bonnet lock mechanisms (5) and (4). The lock mechanisms will drop down, but they can be refitted later!

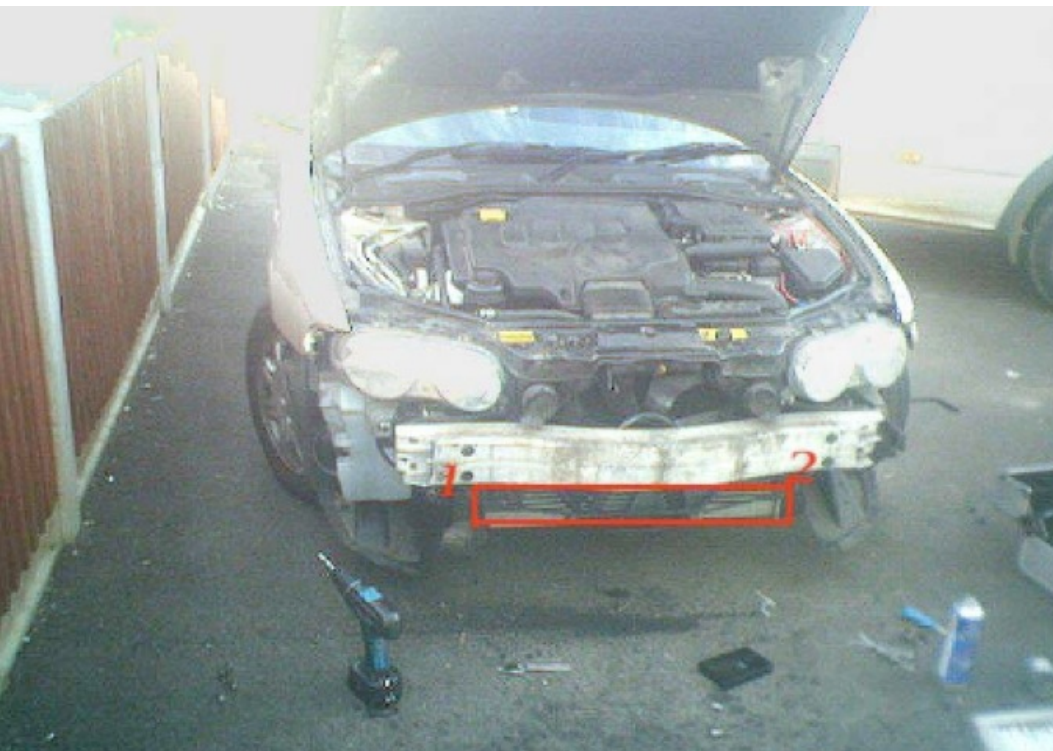
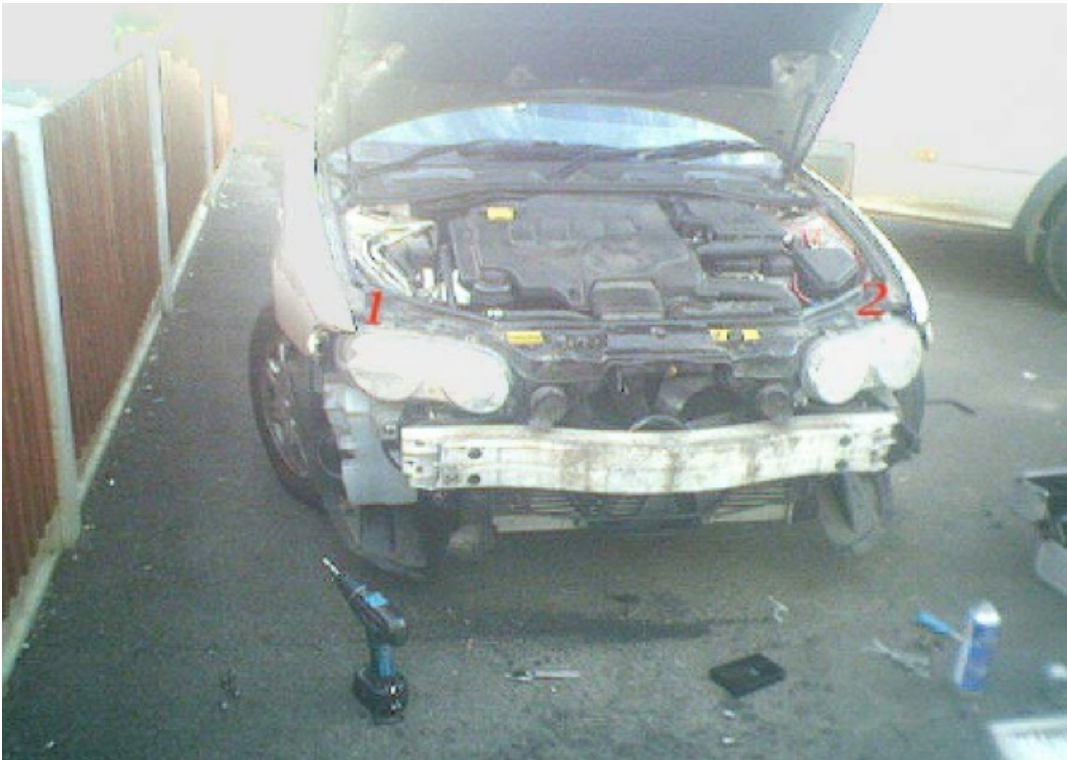
Next you need to \*MOVE\* the power steering cooling loop that sits proud of the radiators from the lower bonnet locking platform. They are attached with one bolt either side. By removing the bolts the cooling loop can be lowered to the ground and moved to one side. The 1st picture shows the location of this loop and the bolts, they are behind the bumper armature (which should be off by now)

You may find you need to also detach the temperature sensor (if fitted) at this time. This can be done with a single bolt that holds it to the power steering cooling loop bracket.

Next, undo the two primary bolts that mate the bonnet locking platform and the wings. These are shown in the 2nd picture as (1) and (2).

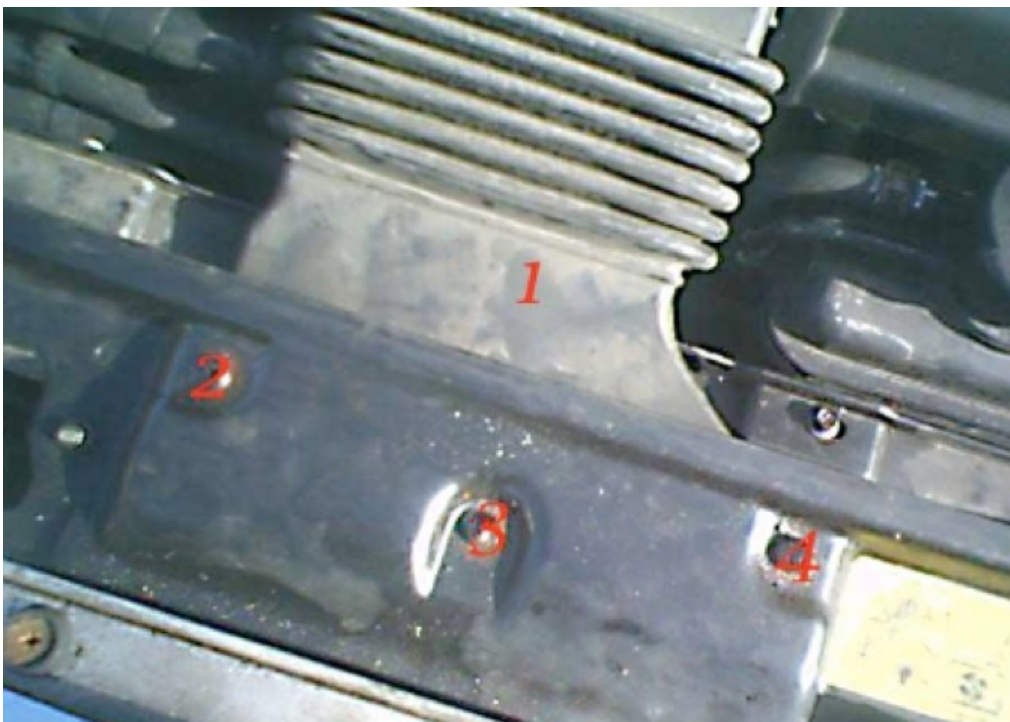
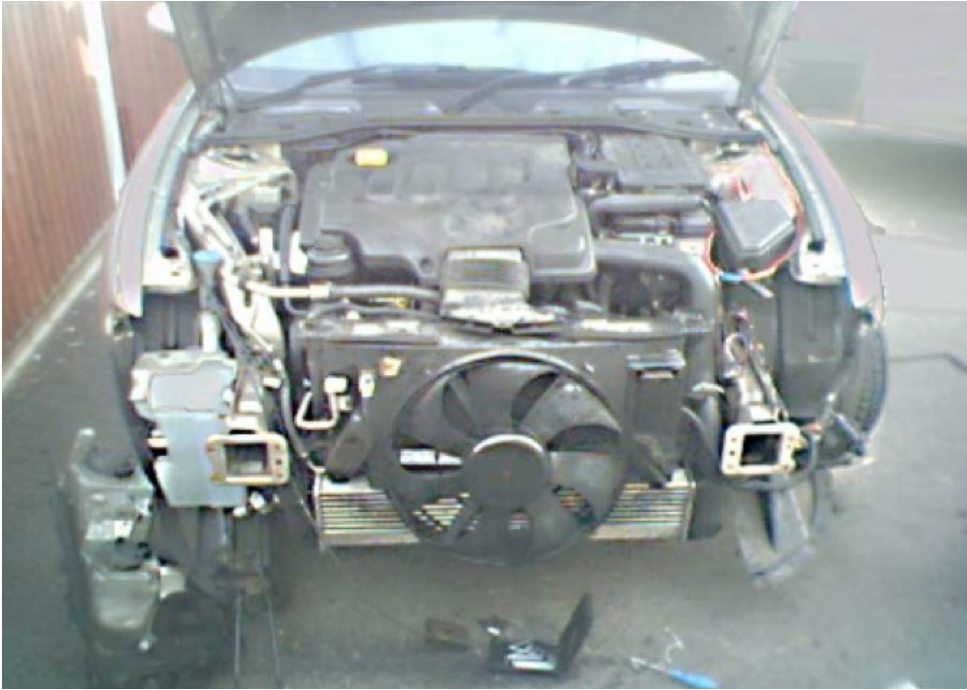
Standing in front of the car - You need to move the locking platform toward you slightly, this will allow you to release the wiring connectors for the headlamps and any other ancillaries attached to the bonnet locking platform. on Diesel models, you'll need to lift the bonnet locking platform up and over the air duct fixers. The 1st picture shows the air duct (1) and the fixing points which protrude downward (2,3 & 4). They do not need to be removed as they are attached to the locking platform and will go with it, you just need to make sure you lift the platform up enough to clear them from their mating holes in the duct.

Now proceed to remove the headlamp connectors on either side, and the temperature sensor connector. With everything detached you can now move the bonnet locking platform to one side, giving you full access to the radiator assembly as shown in the 2nd picture.

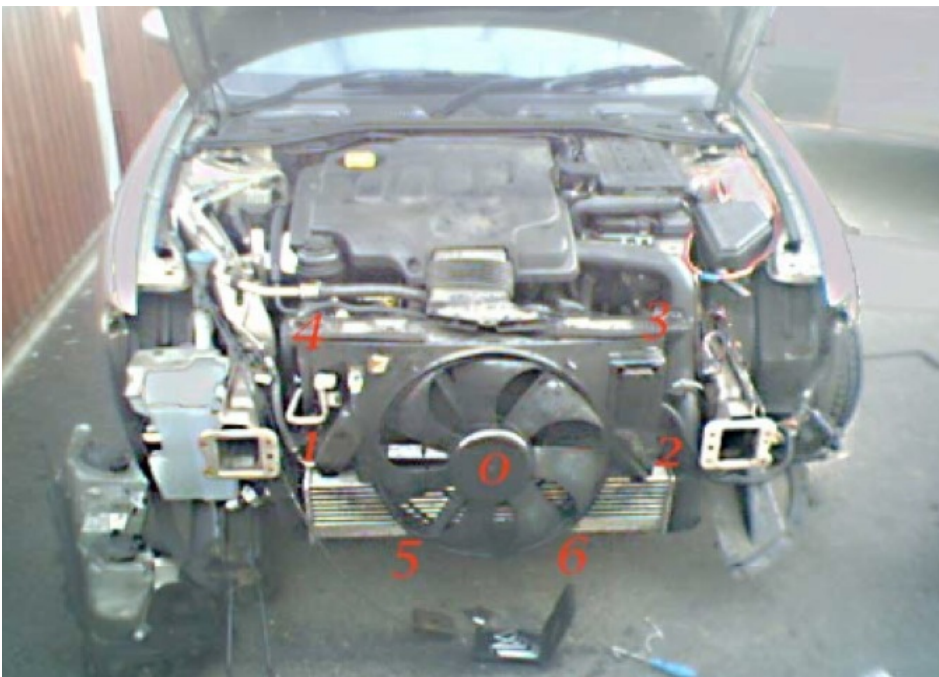
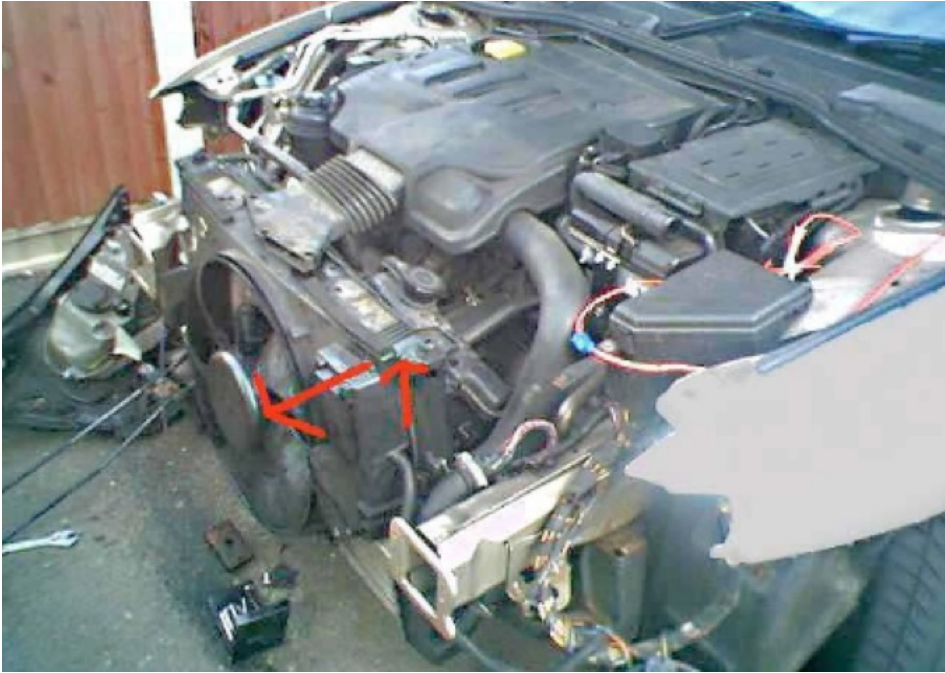
Start by removing the bolts that hold the fan assembly to the radiator, these are shown in Picture 1 as (1,2,5 and 6), note that 5 and 6 attach the fan assembly right at the bottom of the radiator. You'll need to remove the brackets (3) and (4) if you haven't done so already.

You can release the fan itself by holding the nut in the centre (0) and rotating the fan anti-clockwise but **\*DO NOT DO THIS UNLESS YOU MUST\*** as ideally you should replace the fan with a new one after detaching it - although I found I could refit my fan without it being noisy!

This is the 'clever' bit, with the bolts removed. The fan assembly can be hinged around the air con pipes on the left hand side, thereby creating a kind-of door, which allows you enough access to get behind the fan motor and also access the fan relay.

To do this you'll need to apply some upward force to the left hand side of the fan assembly. This is shown in Picture 2. Once lifted over the prang (Picture 1, point 3) extending from the radiator, you can pull the fan assembly away from the car. That's it!
